**DEPARTMENT OF TRANSPORTATION**

Contract #: 04-0120F4Cty: SF/ALA Rte: 80 PM: 13.2/13.9File #: 69.28**WELDING INSPECTION REPORT****Resident Engineer:** Pursell, Gary**Address:** 333 Burma Road**City:** Oakland, CA 94607**Report No:** WIR-011180**Date Inspected:** 05-Jan-2010**Project Name:** SAS Superstructure**OSM Arrival Time:** 700**Prime Contractor:** American Bridge/Fluor Enterprises, a JV**OSM Departure Time:** 1900**Contractor:** Zhenhua Port Machinery Company, Ltd (ZPMC), Changxing Island **Location:** Shanghai, China**CWI Name:** Chen Ying Xin, Tu Jun**CWI Present:** Yes No**Inspected CWI report:** Yes No N/A**Rod Oven in Use:** Yes No N/A**Electrode to specification:** Yes No N/A**Weld Procedures Followed:** Yes No N/A**Qualified Welders:** Yes No N/A**Verified Joint Fit-up:** Yes No N/A**Approved Drawings:** Yes No N/A**Approved WPS:** Yes No N/A**Delayed / Cancelled:** Yes No N/A**Bridge No:** 34-0006**Component:** Tower**Summary of Items Observed:**

**BAY 10 NORTH TOWER LIFT 2 PADEYE OF SKIN E**

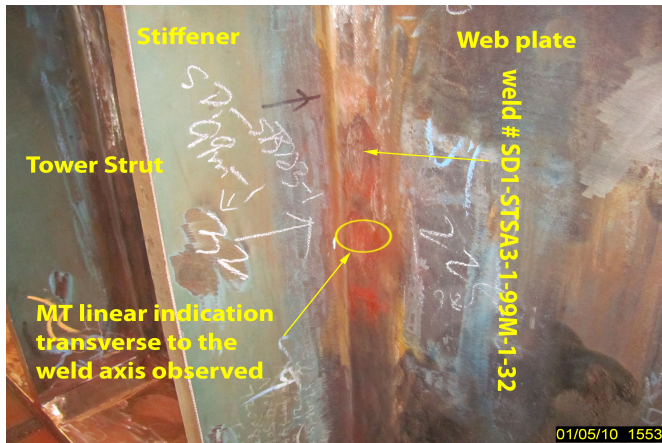
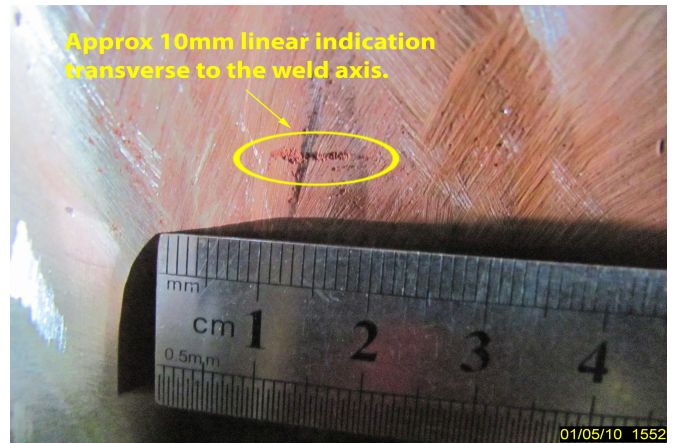
SD1-STSA3-1-99M-1-32 (Approx 10mm in length MT linear indication transverse to weld axis observed)

During the Quality Assurance Magnetic Particle Testing (MT) review of welds located on Tower Strut plate SD1-STSA3-1-99M-1, this Quality Assurance (QA) Inspector discovered one (1) linear indication transverse to the weld axis measuring approximately 10mm in length. The weld is identified as: SD1-STSA3-1-99M-1-32. The Weld is a fillet weld joining the stiffener to the web plate. The material is identified as SPCM. The member is located in Bay 11. The Notice of Witness Inspection Number (NWIT) is 004999. The indication is located inside the area that has been previously tested and accepted by ZPMC Quality Control (QC) personnel. As per the contract documents, ZPMC's QC personnel are required to perform one hundred (100) percent MT inspection of this weld. This issue has an incident report. The attached photographs provide additional detail.
